**Flood Control Project Maintenance
Levee Inspections**

Fall 2016 Levee Maintenance Deficiency Summary Report

Sacramento River Basin

Sacramento River West Side Levee District

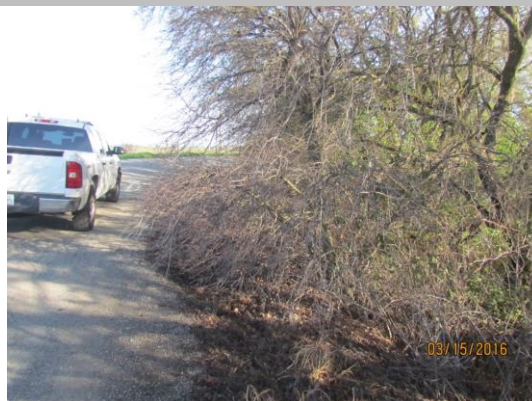
Photo 1 of 1 : FA_2016_NA0016_435_104_20160913_00044.jpg

View of the tree branches on the waterward side of the levee looking upstream. Spring 2016.

LM Start	0.14	Rating **	M	Issue No.	1567
LM End	0.14	Issue Type +	En	Location *	WS
Category	Supplemental			GPS Latitude/Longitude	
				Start	End
Item	DWR UCIP Field Study			38.801471 °	38.801471 °
				-121.725171 °	-121.725171 °
DWR ID					
Comment Code					
Inspector Comment					
FS_ID:10087					
DS_ID:20224					
EP_NO: N/A					
Repair Type: Non-Urgent					
Crossing Status: Found					
UCIP Comments: Headwall on WS undermined about 3-4-feet.					
FIELD_STRUCT_DESC: 1 of 3: 36-inch steel drainage pipe through					
levee 30.0 feet below crown. Flap gate on the waterward end. 24-inch					
pipe sleeved through the 36-inch pipe. Annular space between pipes					
grouted. Pumps in pumphouse with walkway on LS toe. Originally					
included in the 1960 O&M manual.					
FS Date: 3/12/2013

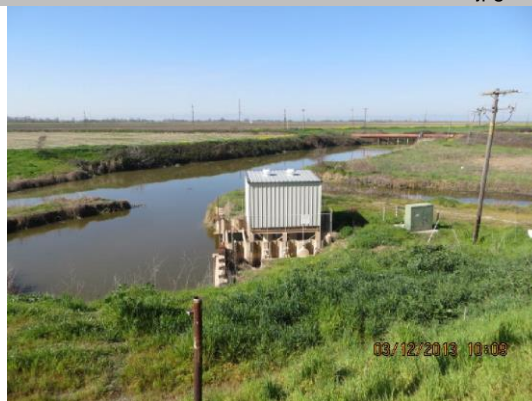
Photo 1 of 2 : UCIP_FA_2016_10087_17235.jpg

Pumphouse at LS toe.

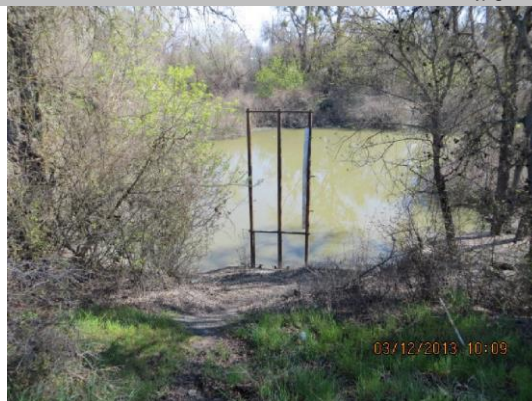
Photo 2 of 2 : UCIP_FA_2016_10087_17234.jpg

LM Start	0.14	Rating **	M	Issue No.	1567 (cont)	
LM End	0.14	Issue Type +	En	Location *	WS	
Category	Supplemental			GPS Latitude/Longitude		
				Start	End	
Item	DWR UCIP Field Study			38.801471 °	38.801471 °	
				-121.725171 °	-121.725171 °	
DWR ID						
Comment Code						
Inspector Comment						
FS_ID:10087						
DS_ID:20224						
EP_NO: N/A						
Repair Type: Non-Urgent						
Crossing Status: Found						
UCIP Comments: Headwall on WS undermined about 3-4-feet.						
FIELD_STRUCT_DESC: 1 of 3: 36-inch steel drainage pipe through						
levee 30.0 feet below crown. Flap gate on the waterward end. 24-inch						
pipe sleeved through the 36-inch pipe. Annular space between pipes						
grouted. Pumps in pumphouse with walkway on LS toe. Originally						
included in the 1960 O&M manual.						
FS Date: 3/12/2013

Air vents at outlet on WS toe.

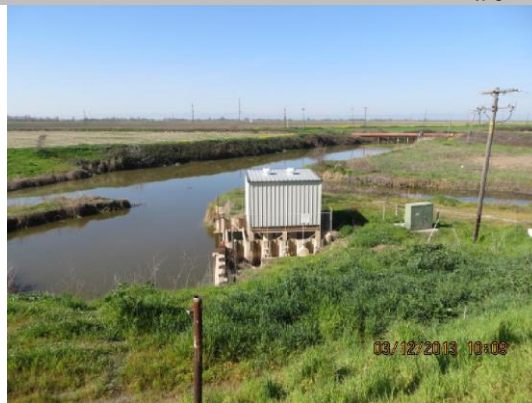
Photo 1 of 2 : UCIP_FA_2016_10085_17227.jpg

LM Start	0.14	Rating **	M	Issue No.	1566
LM End	0.14	Issue Type +	En	Location *	WS
Category	Supplemental			GPS Latitude/Longitude	
				Start	End
Item	DWR UCIP Field Study			38.801479 °	38.801479 °
				-121.725176 °	-121.725176 °
DWR ID					
Comment Code					
Inspector Comment					
FS_ID:10085					
DS_ID:20356					
EP_NO: N/A					
Repair Type: Non-Urgent					
Crossing Status: Found					
UCIP Comments: Headwall undermined 3-4-feet on WS toe.					
FIELD_STRUCT_DESC: 2 of 3: 36-inch steel drainage pipe through levee 30.0 feet below crown. Flap gate on the waterward end. 24-inch pipe sleeved through the 36-inch pipe. Annular space between pipes grouted. Pumps in pumphouse with walkway on LS toe. Originally included in the 1960 O&M manual.					
FS Date: 3/12/2013

Pump house on LS toe.

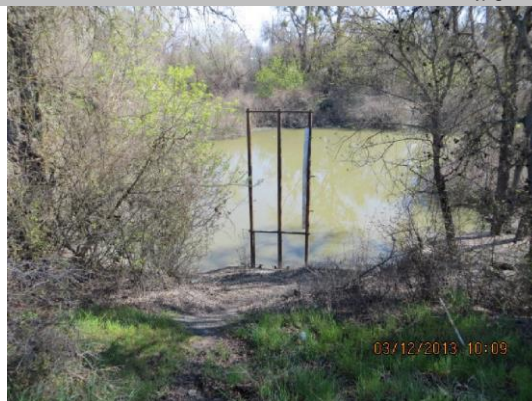
Photo 2 of 2 : UCIP_FA_2016_10085_17226.jpg

LM Start	0.14	Rating **	M	Issue No.	1566 (cont)
LM End	0.14	Issue Type +	En	Location *	WS
Category	Supplemental			GPS Latitude/Longitude	
				Start	End
Item	DWR UCIP Field Study			38.801479 °	38.801479 °
				-121.725176 °	-121.725176 °
DWR ID					
Comment Code					
Inspector Comment					
FS_ID:10085					
DS_ID:20356					
EP_NO: N/A					
Repair Type: Non-Urgent					
Crossing Status: Found					
UCIP Comments: Headwall undermined 3-4-feet on WS toe.					
FIELD_STRUCT_DESC: 2 of 3: 36-inch steel drainage pipe through					
levee 30.0 feet below crown. Flap gate on the waterward end. 24-inch					
pipe sleeved through the 36-inch pipe. Annular space between pipes					
grouted. Pumps in pumphouse with walkway on LS toe. Originally					
included in the 1960 O&M manual.					
FS Date: 3/12/2013

Air vents on pipes at WS toe.

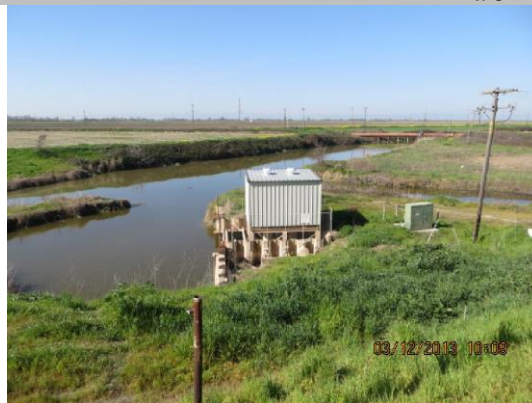
Photo 1 of 2 : UCIP_FA_2016_10910_18185.jpg

LM Start	0.14	Rating **	M	Issue No.	1565
LM End	0.14	Issue Type +	En	Location *	WS
Category	Supplemental			GPS Latitude/Longitude	
				Start	End
Item	DWR UCIP Field Study			38.801491 °	38.801491 °
				-121.725184 °	-121.725184 °
DWR ID					
Comment Code					
Inspector Comment					
FS_ID:10910					
DS_ID:20357					
EP_NO: N/A					
Repair Type: Non-Urgent					
Crossing Status: Found					
UCIP Comments: Headwall undermined 3-4-feet on WS toe.					
FIELD_STRUCT_DESC: 3 of 3: 36-inch steel drainage pipe through levee 30.0 feet below crown. Flap gate on the waterward end. 24-inch pipe sleeved through the 36-inch pipe. Annular space between pipes grouted. Pumps in pumphouse with walkway on LS toe. Originally included in the 1960 O&M manual.					
FS Date: 3/12/2013

Pumphouse on LS toe.

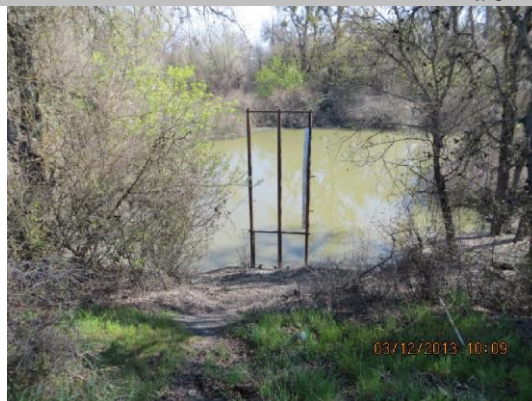
Photo 2 of 2 : UCIP_FA_2016_10910_18184.jpg

LM Start	0.14	Rating **	M	Issue No.	1565 (cont)
LM End	0.14	Issue Type +	En	Location *	WS
Category	Supplemental			GPS Latitude/Longitude	
				Start	End
Item	DWR UCIP Field Study			38.801491 °	38.801491 °
				-121.725184 °	-121.725184 °
DWR ID					
Comment Code					
Inspector Comment					
FS_ID:10910					
DS_ID:20357					
EP_NO: N/A					
Repair Type: Non-Urgent					
Crossing Status: Found					
UCIP Comments: Headwall undermined 3-4-feet on WS toe.					
FIELD_STRUCT_DESC: 3 of 3: 36-inch steel drainage pipe through					
levee 30.0 feet below crown. Flap gate on the waterward end. 24-inch					
pipe sleeved through the 36-inch pipe. Annular space between pipes					
grouted. Pumps in pumphouse with walkway on LS toe. Originally					
included in the 1960 O&M manual.					
FS Date: 3/12/2013

Air vents on pipes at WS toe.

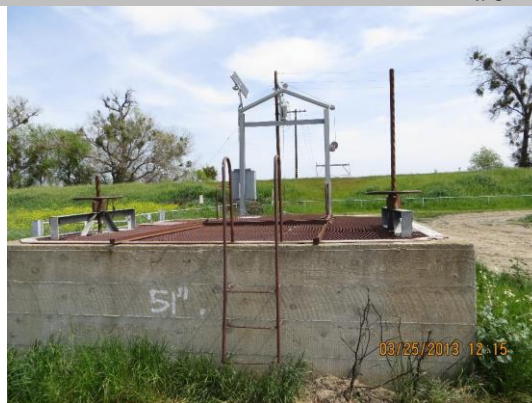
Photo 1 of 2 : UCIP_FA_2016_10103_17262.jpg

Comment Code					
Inspector Comment					
FS_ID:10103 DS_ID:20226 EP_NO: 1331 Repair Type: Non-Urgent Crossing Status: Found UCIP Comments: There is no gate in the slide gate at the concrete distribution box off the landside toe. This may not be an issue as there is a slide gate at the WS toe. FIELD_STRUCT_DESC: 54-inch corrugated metal irrigation pipe through levee 28.0 feet below crown. Vertical pumps on pile structure in the stream, walkway to pumps. Flap gates from pumps and slide gate inside a 7'X10-foot concrete surge box on the waterward side, 1948 installation. 15'X18-foot concrete distribution box 150-feet off landside toe with slide gate. (Permit No. 1331, 1948). Included in 1960 O&M manual. FS Date: 3/25/2013 7:36:51 AM

Concrete distribution box on 150-feet off landside toe.

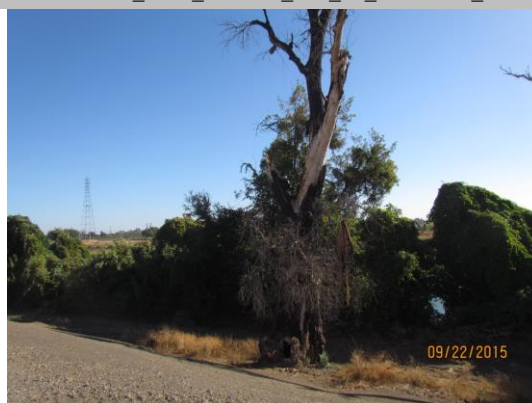
Photo 1 of 1 : FA_2016_NA0016_435_82_20160913_00033.jpg

View of the dying tree on the waterward side of the levee. Monitor trees that could pose a threat to the integrity of the levee. Fall 2015.

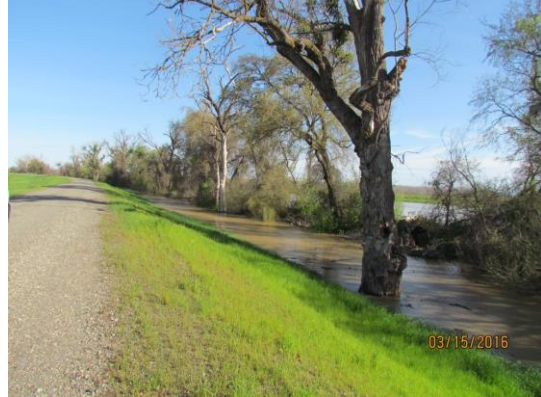
Photo 1 of 1 : FA_2016_NA0016_435_84_20160913_00035.jpg

View of the tree on the waterward side of the levee looking upstream.
Spring 2016.

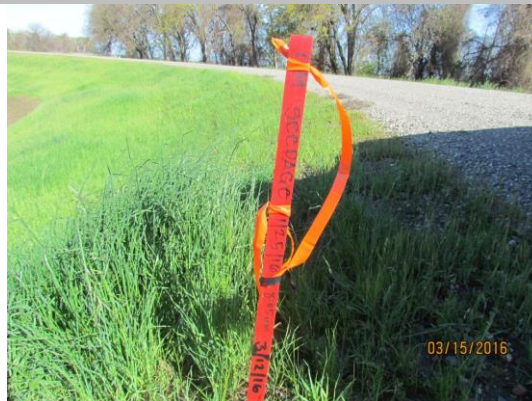
Photo 2 of 2 : FA_2016_NA0016_435_153_20160913_00080.jpg

LM Start	4.00	Rating **	U	Issue No.	153
LM End	4.15	Issue Type +	Ob	Location *	LS
Category	Earthen Levee			GPS Latitude/Longitude	
				Start	End
Item	Seepage / Sandboils			38.851382 °	38.851991 °
				-121.724708 °	-121.727000 °
DWR ID	DWR_NA0016_01_s_2016_153				
Comment Code					
Inspector Comment					
Seepage area has been staked and noted by LMA. Monitor seepage site.

LMA has staked seepage area and are monitoring the situation.

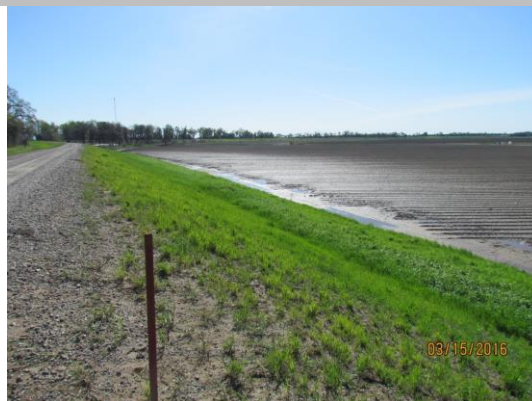
Photo 2 of 2 : FA_2016_NA0016_435_111_20160913_00056.jpg

LM Start	4.99	Rating **	U	Issue No.	111
LM End	5.09	Issue Type +	Ob	Location *	LS
Category	Earthen Levee			GPS Latitude/Longitude	
				Start	End
Item	Seepage / Sandboils			38.859909 °	38.860409 °
				-121.736119 °	-121.738001 °
DWR ID	DWR_NA0016_01_s_2016_111				
Comment Code					
Inspector Comment					
Seepage area has been staked and noted by LMA. Monitor seepage site.

View of the seepage on the landward side of the levee looking downstream. Spring 2016.

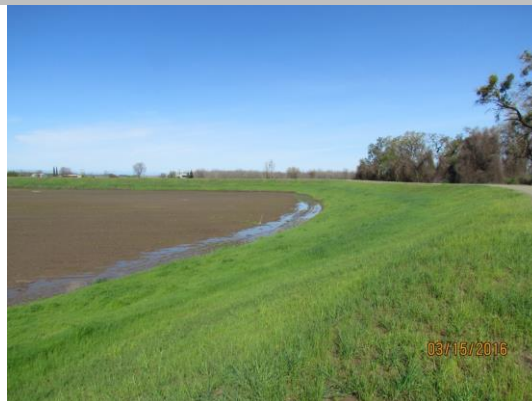
Photo 1 of 3 : FA_2016_NA0016_435_152_20160913_00076.jpg

LM Start	6.12	Rating **	U	Issue No.	152
LM End	6.12	Issue Type +	Ob	Location *	LS
Category	Earthen Levee			GPS Latitude/Longitude	
				Start	End
Item	Seepage / Sandboils			38.870503 °	38.870503 °
				-121.750068 °	-121.750068 °
DWR ID	DWR_NA0016_01_s_2016_152				
Comment Code					
Inspector Comment					
Seepage area has been staked and noted by LMA. Monitor seepage site.

View of the seepage on the landward side of the levee looking upstream. Spring 2016.

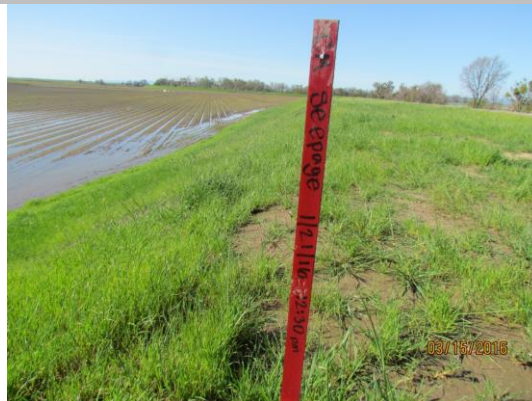
Photo 3 of 3 : FA_2016_NA0016_435_152_20160913_00078.jpg

LM Start	6.12	Rating **	U	Issue No.	152 (cont)	
LM End	6.12	Issue Type +	Ob	Location *	LS	
Category	Earthen Levee			GPS Latitude/Longitude		
				Start	End	
Item	Seepage / Sandboils			38.870503 °	38.870503 °	
				-121.750068 °	-121.750068 °	
DWR ID	DWR_NA0016_01_s_2016_152					
Comment Code						
Inspector Comment						
Seepage area has been staked and noted by LMA. Monitor seepage site.

LMA monitoring stake for the seepage. Spring 2016.

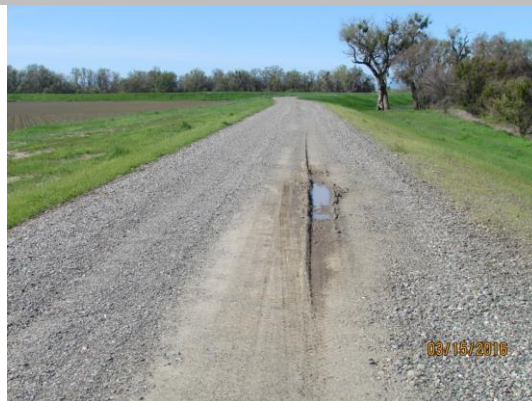
Photo 1 of 1 : FA_2016_NA0016_435_154_20160913_00081.jpg

LM Start	6.31	Rating **	M	Issue No.	154
LM End	6.31	Issue Type +	Ma	Location *	CR
Category	Earthen Levee			GPS Latitude/Longitude	
				Start	End
Item	Crown Surface / Depressions / Rutting			38.869088 °	38.869088 °
				-121.753220 °	-121.753220 °
DWR ID	DWR_NA0016_01_s_2016_154				
Comment Code					
C2 : Repair depressions or ruts in the crown or slope.					
Inspector Comment

View of the rut on the crown of the levee looking upstream. Spring 2016.

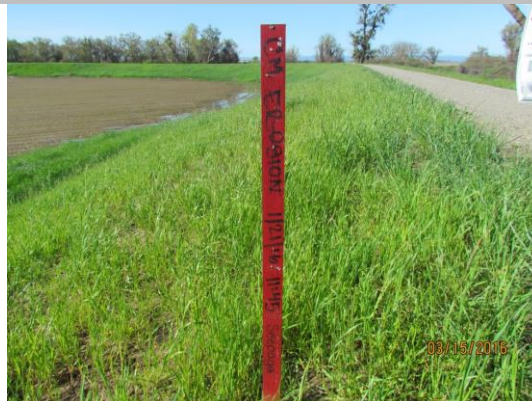
Photo 2 of 2 : FA_2016_NA0016_435_156_20160913_00083.jpg

LM Start	6.50	Rating **	U	Issue No.	156
LM End	6.62	Issue Type +	Ob	Location *	LS
Category	Earthen Levee			GPS Latitude/Longitude	
				Start	End
Item	Seepage / Sandboils			38.868127 °	38.867530 °
				-121.756499 °	-121.758427 °
DWR ID	DWR_NA0016_01_s_2016_156				
Comment Code					
Inspector Comment					
Seepage area has been staked and noted by LMA. Monitor seepage site.

Stake marks the seepage site on the levee prism and is placed on the landward shoulder. Spring 2016.

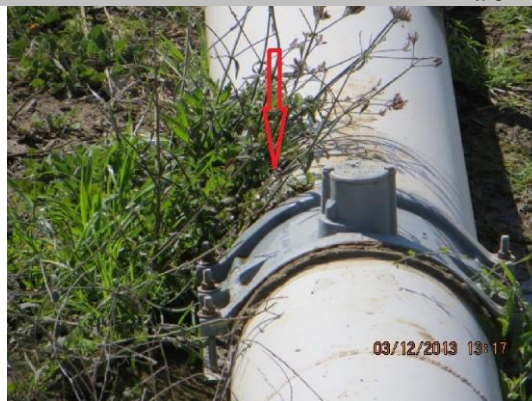
Photo 1 of 2 : UCIP_FA_2016_10129_17291.jpg

Comment Code						
Inspector Comment						
FS_ID:10129						
DS_ID:20228						
EP_NO: 1297						
Repair Type: Non-Urgent						
Crossing Status: Found						
UCIP Comments: Leak at flowmeter on WS berm may become problem in near future.						
FIELD_STRUCT_DESC: *REMOVED*2 of 2: 16-inch steel pipe through levee 5.2 feet below crown. Slant pumps in metal pump house on the waterward bank, supported on steel structure. Pipes discharge into 9.5'x12' concrete distribution box on the landward side. Sparline flow meter on pipes near the waterward toe. (Permit No. 1297, 1948). Also included in the 1960 O&M manual. Removed under permit No. 8501, 2012.						
FS Date: 3/12/2013

Minor leak at flowmeter on WS berm.

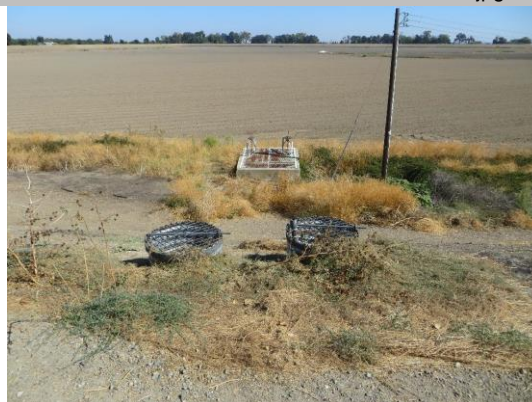
Photo 2 of 2 : UCIP_FA_2016_46765_74701.jpg

FS_ID:46765
DS_ID:25125
EP_NO: 8501
Repair Type: Non-Urgent
Crossing Status: Found
UCIP Comments: field inspection of the site revealed a few minor actions: 1. there are metal fence posts located near the pipe that should be cleared out for safety, 2. vegetation around the pipes should be cleared as it limits inspection, 3. some burrowing activity was noticed nearby the pipes.
FIELD_STRUCT_DESC: A 20 inch steel pipe and a 16 inch steel pipe are located at levee mile 6.889 and 6.89, respectively. Both pipes have a protective paint coating. The pipes are used to supply irrigation water to the adjacent fields. On the water side of the levee, the pipes are above ground and follow the slope of the bank into the river. A metal pumphouse, supported on a steel frame is located on a bench on the waterside of the levee. When the pumps are operational a drum fish screen is lowered over the pipe intakes on a track. Both irrigation pipes travel through the levee and have siphon breakers in CMP risers on the land side crest of the levee. The pipes discharge under submerged conditions to a 9.5 ft x 12 ft concrete distribution box. There are two gated outlets on the distribution box that lead to distribution canals.

view from levee crest along pipe profile toward land side of levee. CMP risers with siphon breakers and distribution box near land side levee toe.

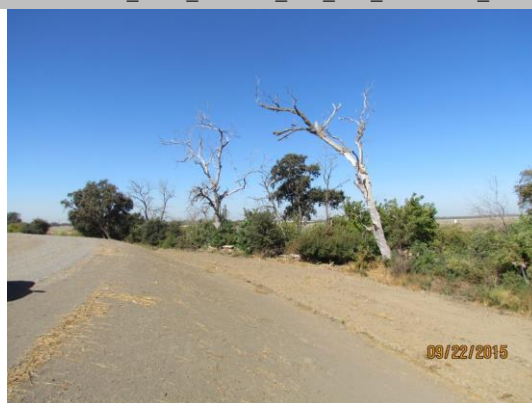
Photo 1 of 1 : FA_2016_NA0016_435_114_20160913_00058.jpg

View of the dying tree on the waterward side of the levee looking upstream. Fall 2015.

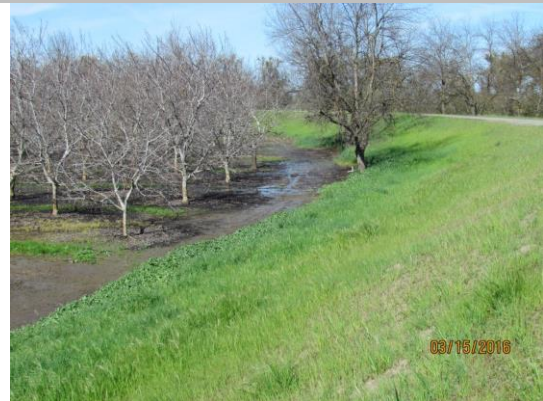
Photo 1 of 2 : FA_2016_NA0016_435_161_20160913_00086.jpg

View of the seepage on the landward side of the levee looking upstream.
Spring 2016.

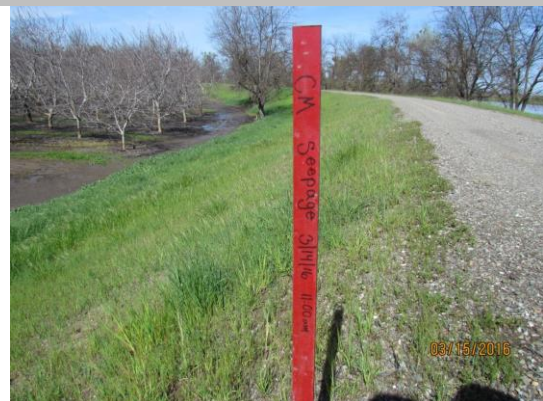
Photo 2 of 2 : FA_2016_NA0016_435_161_20160913_00087.jpg

Stake shows LMA is monitoring the seepage. Spring 2016.

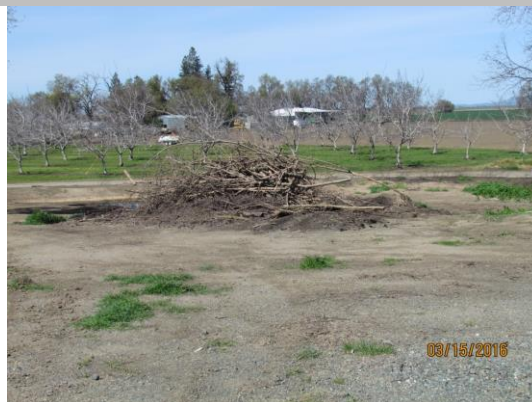
Photo 1 of 1 : FA_2016_NA0016_435_95_20160913_00039.jpg

View of the debris pile on the landward side of the levee. Spring 2016.

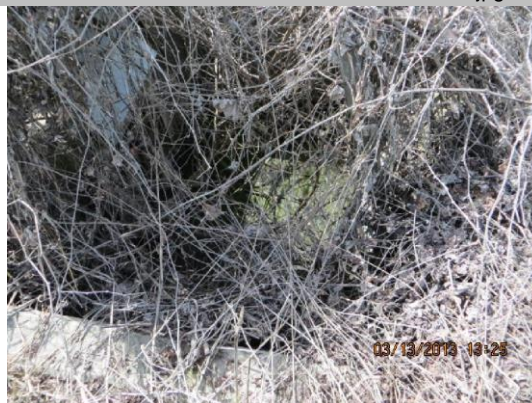
Photo 2 of 2 : UCIP_FA_2016_10253_17448.jpg

Concrete distribution box under heavy blackberry cover at LS toe.

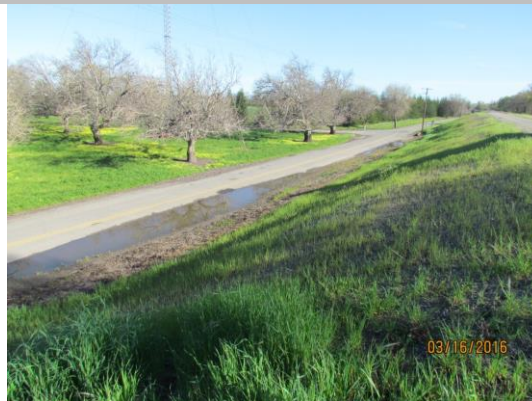
Photo 1 of 1 : FA_2016_NA0016_435_188_20160913_00103.jpg

View of the seepage on the landward side of the levee looking upstream. Spring 2016.

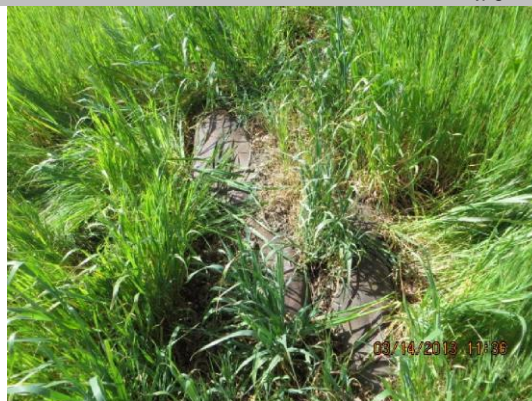
Photo 1 of 2 : UCIP_FA_2016_10290_17545.jpg

Pipe debris on WS slope.

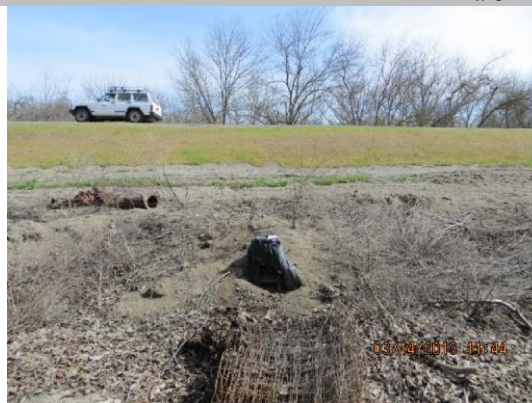
Photo 1 of 2 : UCIP_FA_2016_10291_17548.jpg

Gate valve buried on LS toe.

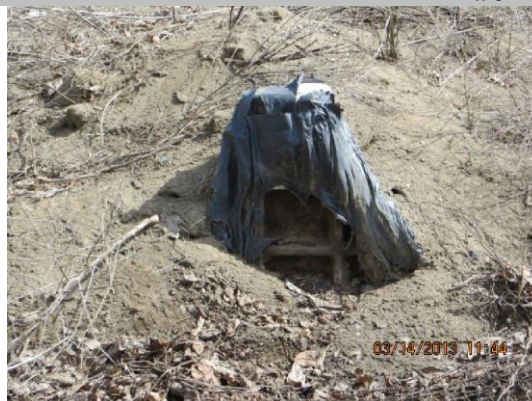
Photo 2 of 2 : UCIP_FA_2016_10291_17547.jpg

Gate valve buried on LS toe.

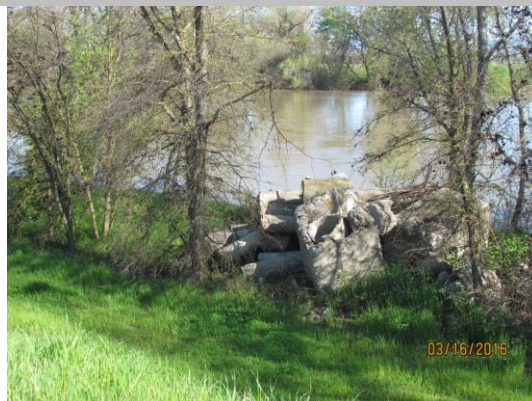
Photo 1 of 1 : FA_2016_NA0016_435_59_20160913_00031.jpg

View of the pile of concrete on the waterward berm of the levee. Spring 2016.

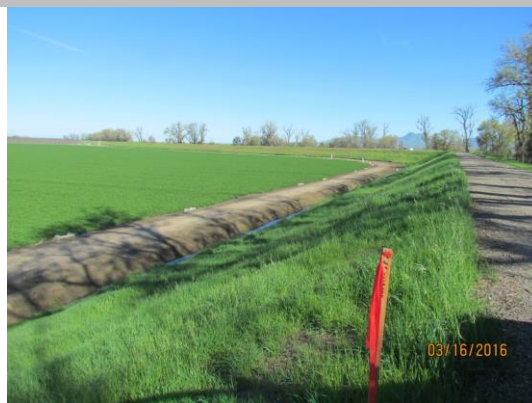
Photo 1 of 2 : FA_2016_NA0016_435_197_20160913_00106.jpg

View of the seepage into the ditch on the landward side of the levee looking upstream. Spring 2016.

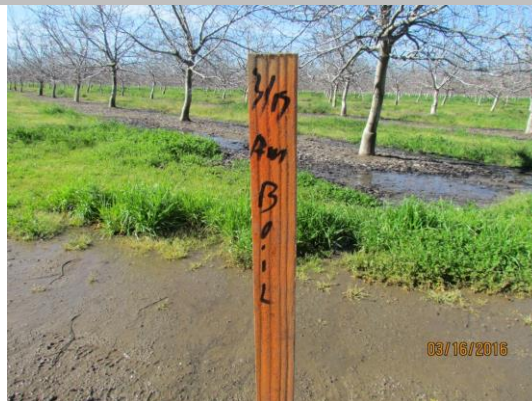
Photo 3 of 3 : FA_2016_NA0016_435_201_20160913_00113.jpg

Monitoring stake was placed on 3/15/16. Spring 2016.

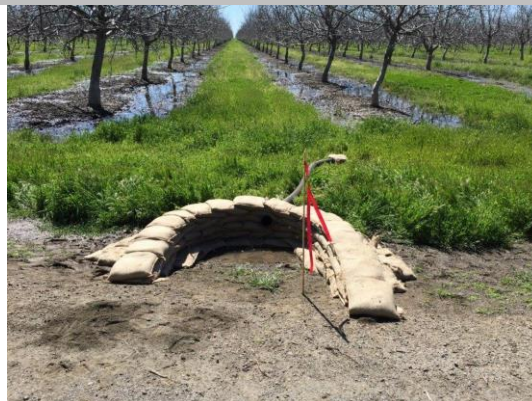
Photo 3 of 3 : FA_2016_NA0016_435_202_20160913_00116.jpg

LMA has constructed sack ring around the boil and will continue to monitor it. Spring 2016.

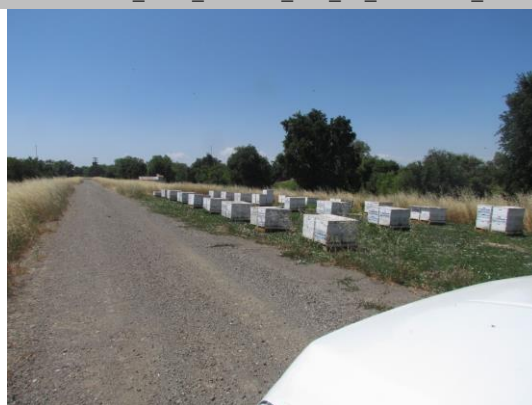
Photo 1 of 1 : FA_2016_NA0016_435_99_20160913_00042.jpg

View of the beehives on the shoulder of the waterward side of the levee looking upstream. Spring 2015.

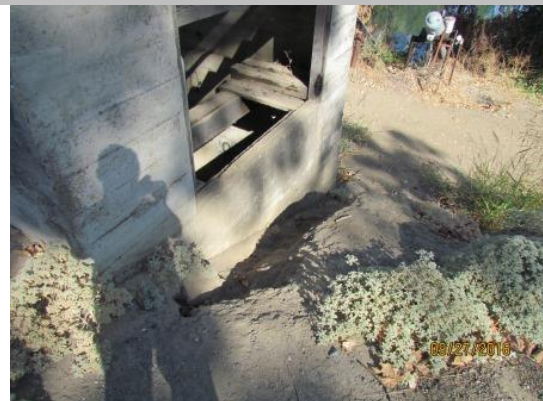
Photo 1 of 1 : FA_2016_NA0016_435_80_20160929_00244.jpg

Slope stability issue at the wall of the building. Waterside slope. Fall 2016 inspection.

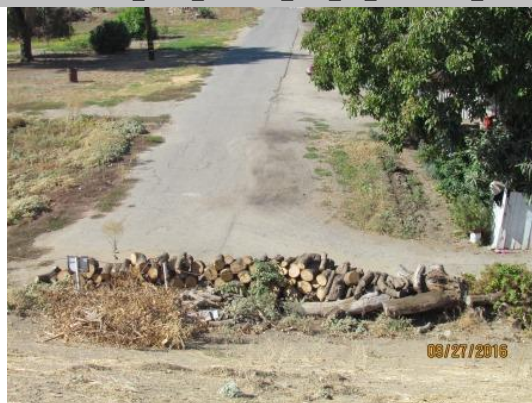
Photo 1 of 1 : FA_2016_NA0016_435_87_20160929_00247.jpg

Firewood within 10 feet of levee toe on landside. Fall 2016 inspection.

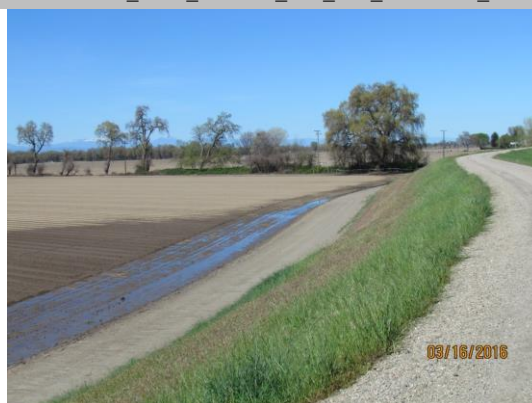
Photo 1 of 1 : FA_2016_NA0016_435_207_20160913_00117.jpg

View of the seepage on the landward side of the levee looking upstream. Spring 2016.

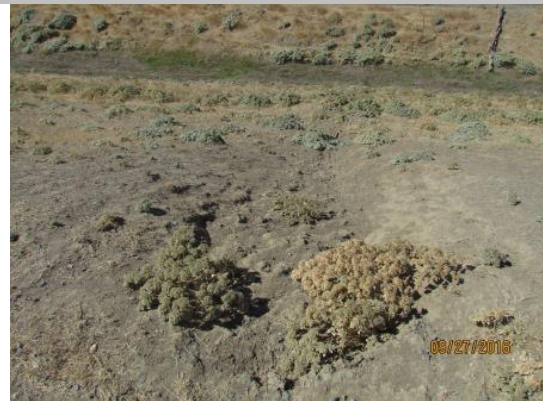
Photo 1 of 1 : FA_2016_NA0016_435_146_20160929_00251.jpg

Slope stability issue due to foot traffic. Fall 2016 inspection.

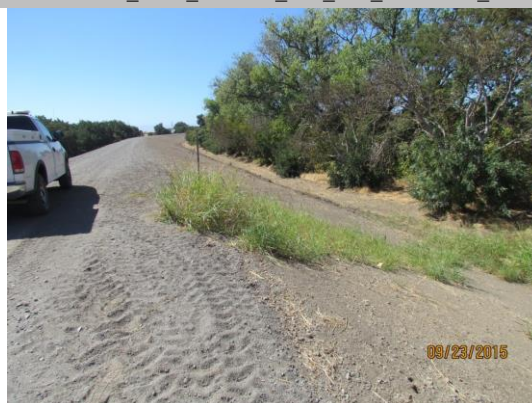
Photo 3 of 6 : FA_2016_NA0016_435_109_20160913_00050.jpg

Perspective view of the vegetation where the pipe runs through the levee on the waterward side of the levee looking upstream. Fall 2015.

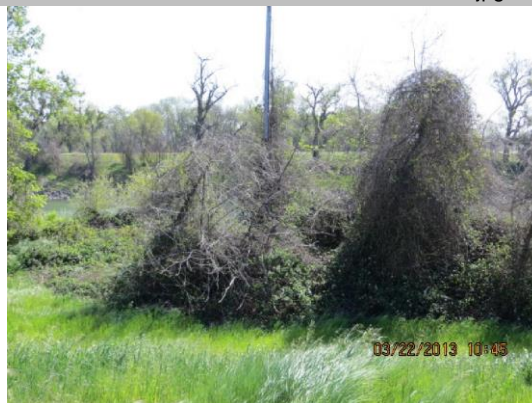
Photo 2 of 2 : UCIP_FA_2016_10566_17953.jpg

Pump covered in brush on WS berm.
